**CALIFORNIA REGIONAL WATER QUALITY CONTROL BOARD - SAN DIEGO REGION
WATERSHED MANAGEMENT PROGRAM**

FACILITY INSPECTION REPORT

INSPECTION DATE: 8/10/01 TIME: 11:30 WDID: 9335315165

38000 Hwy 79 South
FACILITY STREET ADDRESS

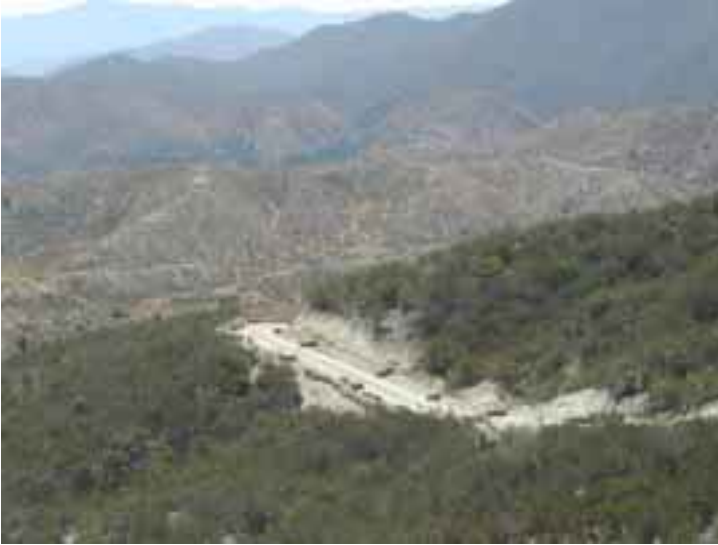
**Photograph No. 1**

Graded access roads, lower portion of road has straw bales as chevrons as sediment control BMP.

Straw bale chevrons (sediment control BMP) can be seen placed along the graded road from the lake trailer to the first pad.

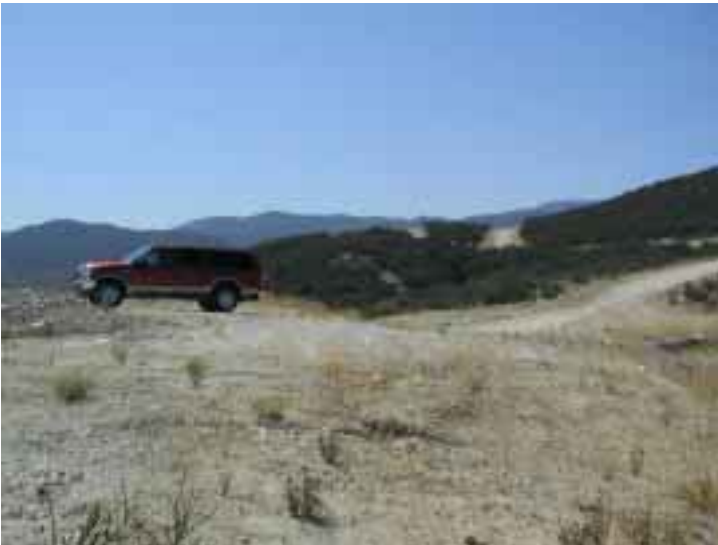
**Photograph No. 2**

View of the first of five graded pads overlooking Vail Lake. The graded road that contours around Vail Lake can also be seen in the background.

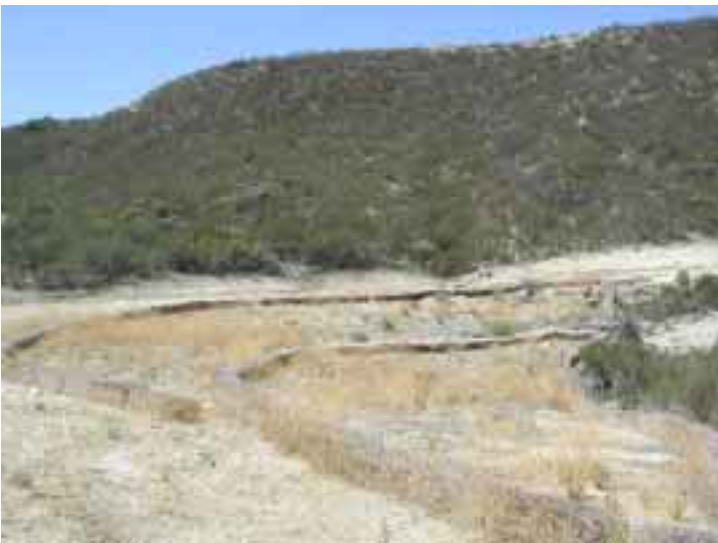
**Photograph No. 3**

Straw bales & deteriorated Jute netting are utilized as sediment control, most likely not effective during rain event.

View of graded road to second pad from the first pad. Hay bales line the road downslope (sediment control BMP).

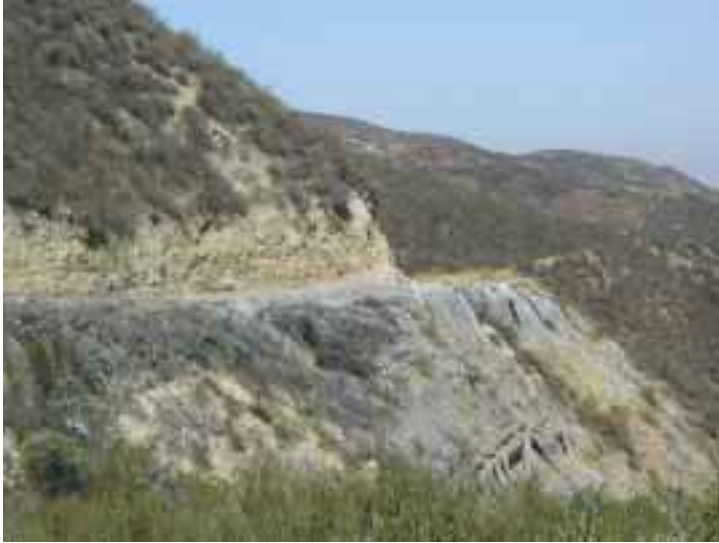
**Photograph No. 4**

Due to Failure on road, (road cut failed) unable to investigate the complete site.

View of graded road to second pad from the first pad. Jute mats were laid on the downslopes as an erosion control BMP. Portions of the cut hillside sloughed off onto the road and prevented the Regional Board from continuing past this point.

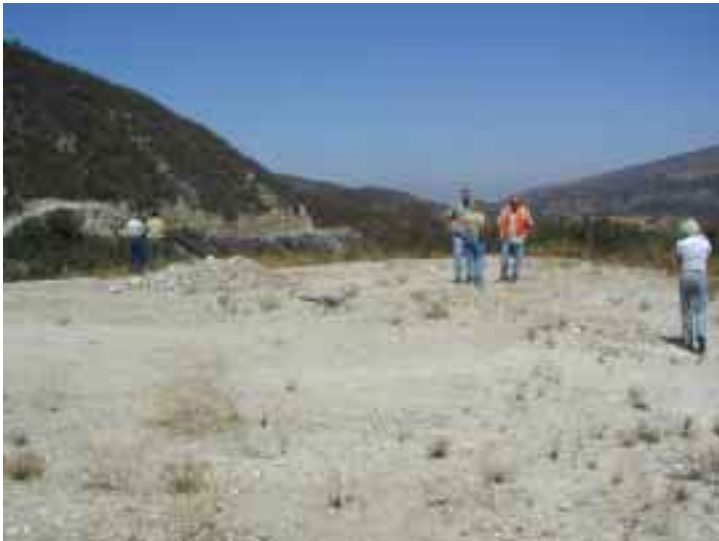
**Photograph No. 5**

View of the first of five graded pads overlooking Vail Lake. The pads lacked erosion and sediment control BMPs to prevent the discharge of runoff into Vail Lake.

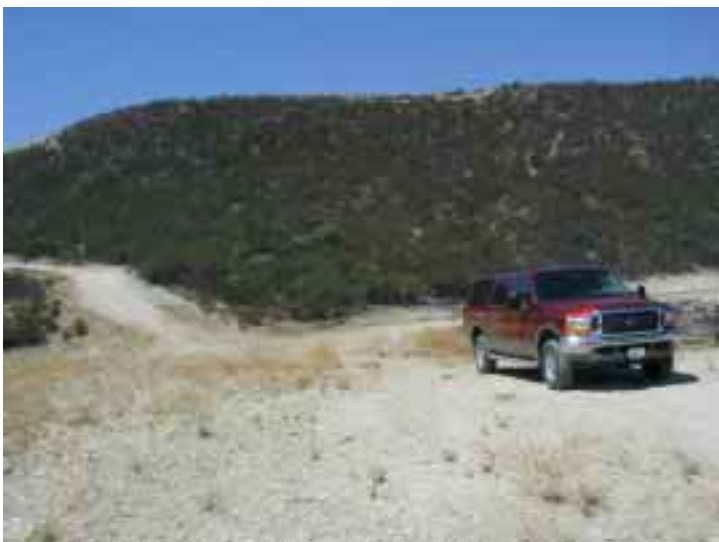
**Photograph No. 6**

View of the first of five graded pads overlooking Vail Lake.
